CASE STUDY - FISHING

DYNASTY RECOVERS WADDED UP SAND LINE INSIDE OF 4 1/2", 11.60# CASING

LOCATION: Wray, Colorado. USA

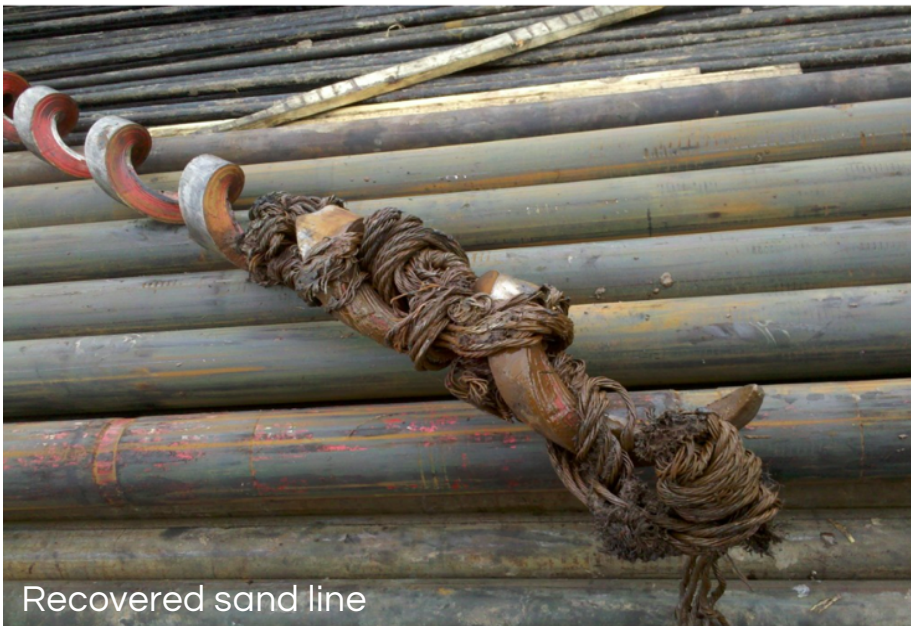
Sand line parted with over 300' of sand line remaining inside of 4 1/2" 11.6# casing. Rig company ran a bit in well in attempt to "push down" the parted sand line below the perforations. This resulted in a "bird's nest" of sand line, balled up inside the casing and packed tightly to the casing ID.

Run Scru-Grab tool to clear out the "Birds nest" and pull the remaining sand line from the hole to the satisfaction of the customer. The fishing job was successful and completed in 3 trips.

- Wireline Scru-Grab with a 3 7/8" OD stop plate to keep wire from getting up around the jars
- Bumper Jar
- Oil Jar
- 4 Drill Collars
- Crossover Sub
